**Thorndale Bridge Improvements
Environmental Impact Study**

May 8, 2020

THORNDALE BRIDGE IMPROVEMENTS ENVIRONMENTAL IMPACT STUDY

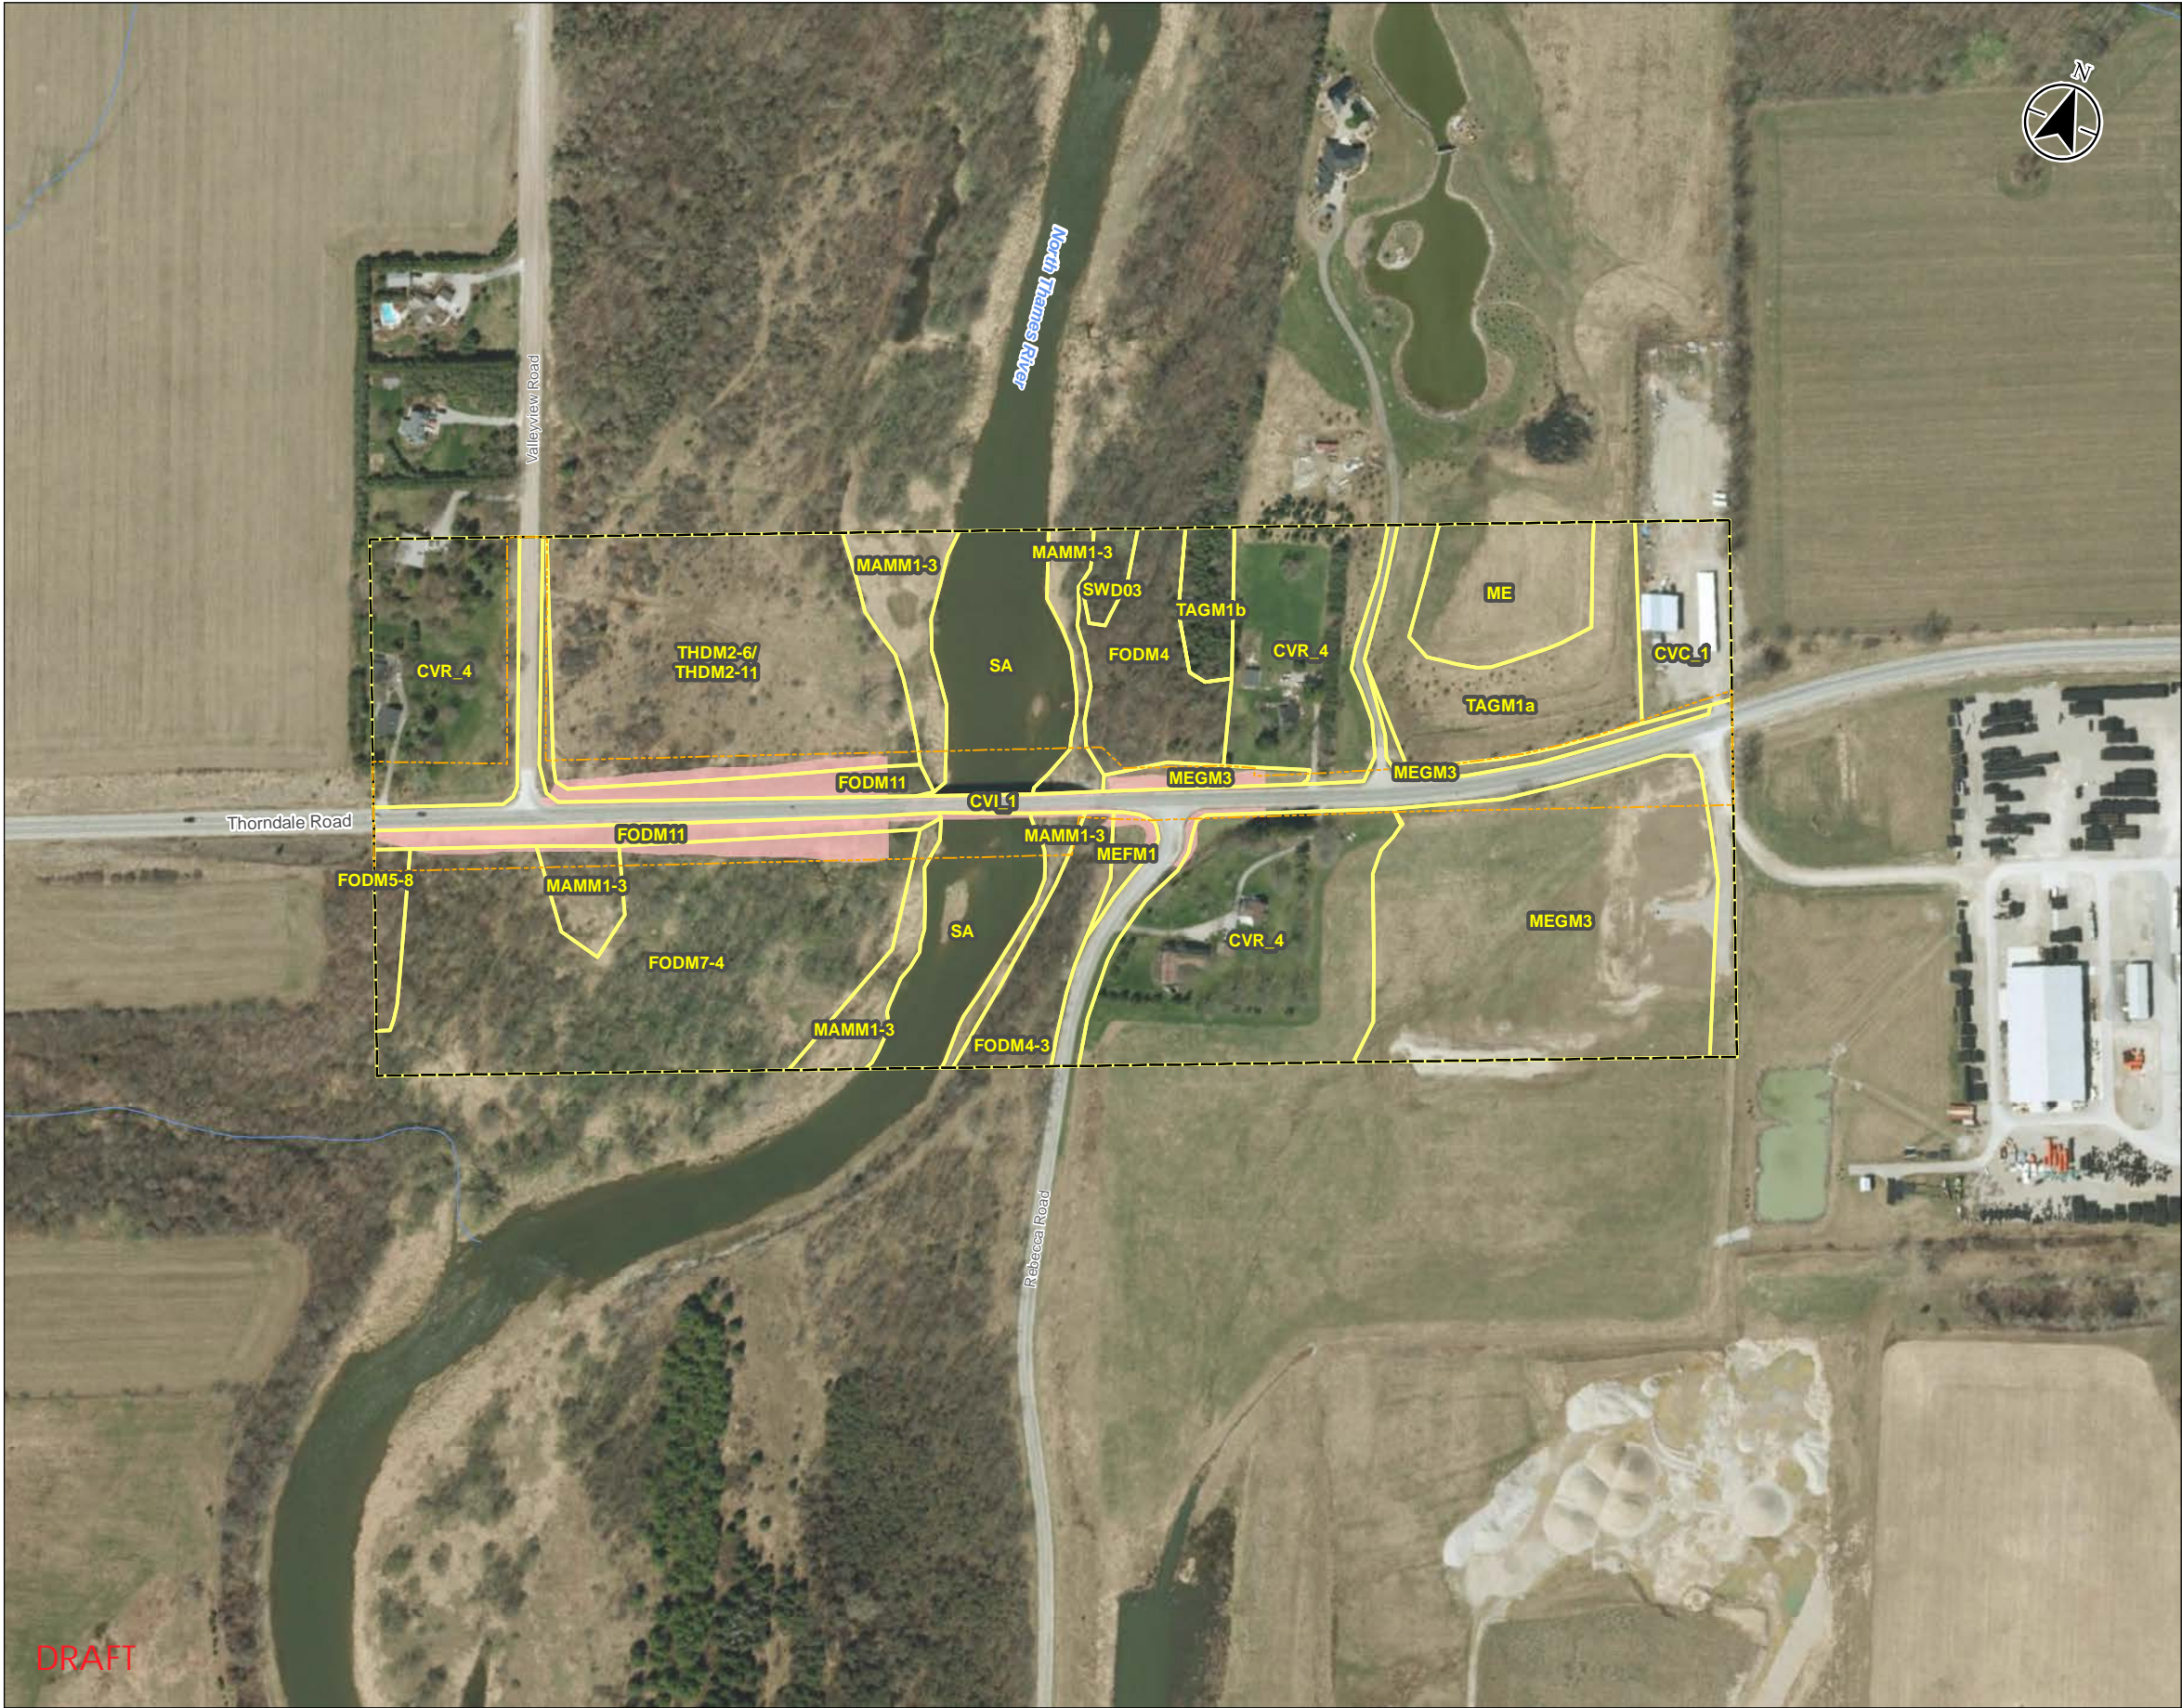
- ELC LEGEND**
- CVC_1 Storage Facility
 - CVI_1 Transportation
 - CVR_4 Rural Property
 - FODM11 Naturalized Deciduous Hedge-row
 - FODM4-3 Dry - Fresh Upland Deciduous Forest
 - FODM4-3 Steep slope to river dominated by hackberry
 - FODM5-8 Sugar Maple-Ash forest on slope
 - FODM7-4 Black walnut floodplain forest / woodland
 - MAMM1-3 Floodplain Marsh
 - MAMM1-3 Frob Bedrock Meadow Marsh
 - MAMM1-3 Riverside marsh
 - MAMM1-3 Riverside marsh
 - ME Meadow
 - MEFM1 Forb Meadow
 - MEGM3 Dry - Fresh Graminoid Meadow
 - SA Shallow Water
 - SWD03 Wetland
 - TAGM1a Meadow and young planted conifers
 - TAGM1b Coniferous Plantation
 - THDM2-6/ THDM2-11 Thicket

Fifteen vegetation community types were identified in the Study Area, including 11 natural or naturalized types, one plantation type and three cultural types based on by ELC for Southern Ontario (Lee et al., 1998) and the updated 2008 ELC Catalogue. Narrow marsh communities were present along the North Thames River, woodland communities covered most of the valley and slopes, and meadow or cultural communities were common on the plateau above the river valley. One provincially rare vegetation community (Fresh-Moist Black Walnut Lowland Deciduous Forest, FODM7-4, S2S3) is present south of the bridge on the west side of the North Thames River. This floodplain woodland is dominated by the regionally-rare tree Black Walnut, however much of the ground layer is comprised of non-native or invasive species common to southern Ontario.

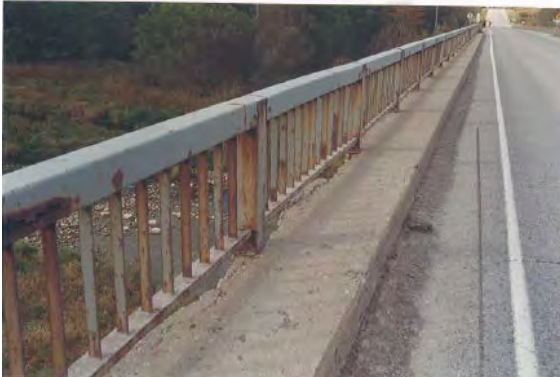
Plate 8: Curb and railing on south side looking west in 1999 (Dillon Consulting Limited 1999)

An Inspection Report of the bridge was completed in 1999 by Dillon Consulting Limited. The report recommended the installation of a supplementary steel flexbeam guiderail and the completion of a corrosion survey to estimate the extent of deterioration of the deck (Dillon Consulting Limited 1999). Photographs from the 1999 report show the condition of the bridge that year (Plate 8 to Plate 11).

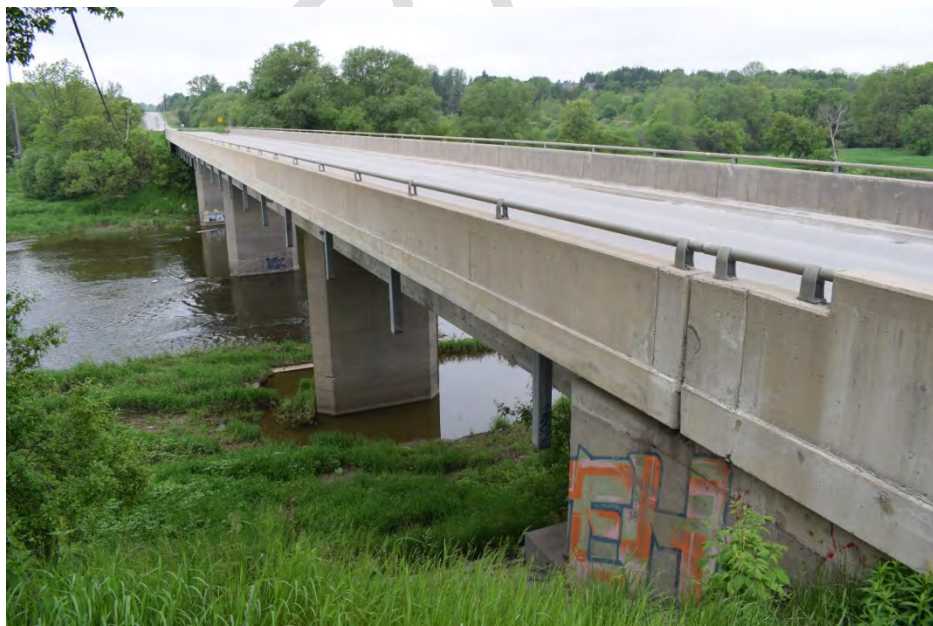
Plate 25: Thorndale Bridge looking northwest

Thorndale Bridge is a four-span cast-in-place concrete two-cell box girder bridge (Plate 25). The four continuous spans are 24.4 m, 30.5 m, 30.5 m, and 24.4 m in length. The bridge has no skew. The current roadway width is 7.5 m and the current structure width is 9.5 m (Plate 26 to Plate 28). The wearing surface is asphalt (Plate 29). There is a concrete parapet wall with a single rail and curb on each side of the bridge (Plate 30). A steel beam guide rail is attached to all four parapet wall ends (Plate 31). Each side of the deck has eighteen deck drains spaced at 6 m (Plate 32 to Plate 34). There is an expansion joint at each abutment (Plate 35 and Plate 36).
